Effective Road Pavement Reconstruction in the Fraser Coast Region QLD

A dissertation submitted by
Kaz Chapman-Vagg

in fulfilment of the requirements of
ENG4111 and 4112 Research Project
towards the degree of
Bachelor of Engineering (Honours) (Civil)
Submitted October, 2020

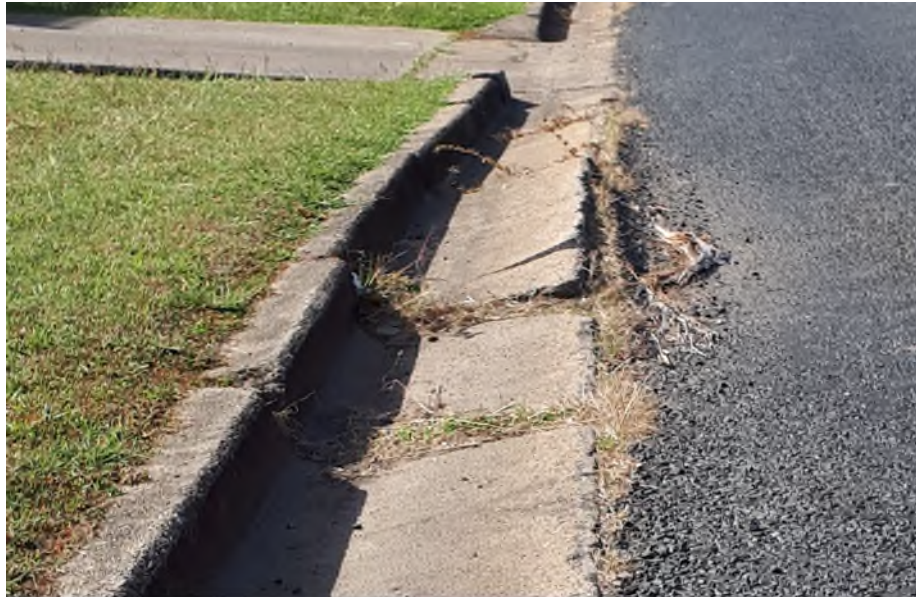
Figure 3.4: Kerb and Channel failure in Fraser Coast

The rolled back profile of this kerb and the adjacent pavement failure is representative of the effect that expansive soils can have on road infrastructure. Nelson et al. (2015) wrote that expansive soils consist primarily of clay particles which swell when exposed to moisture and shrink when moisture is expelled from the particles. As such, it is of paramount importance to prevent the ingress of water into the pavement and subgrade material while also providing drainage structures to drain moisture (Nelson et al, 2015). This was corroborated by Das (2010) who suggested that the volumetric changes in subgrade can be the greatest cause of duress to pavements (Das, 2010). Figure 3.5 is an illustration of the behaviour of expansive clay when exposed to moisture.

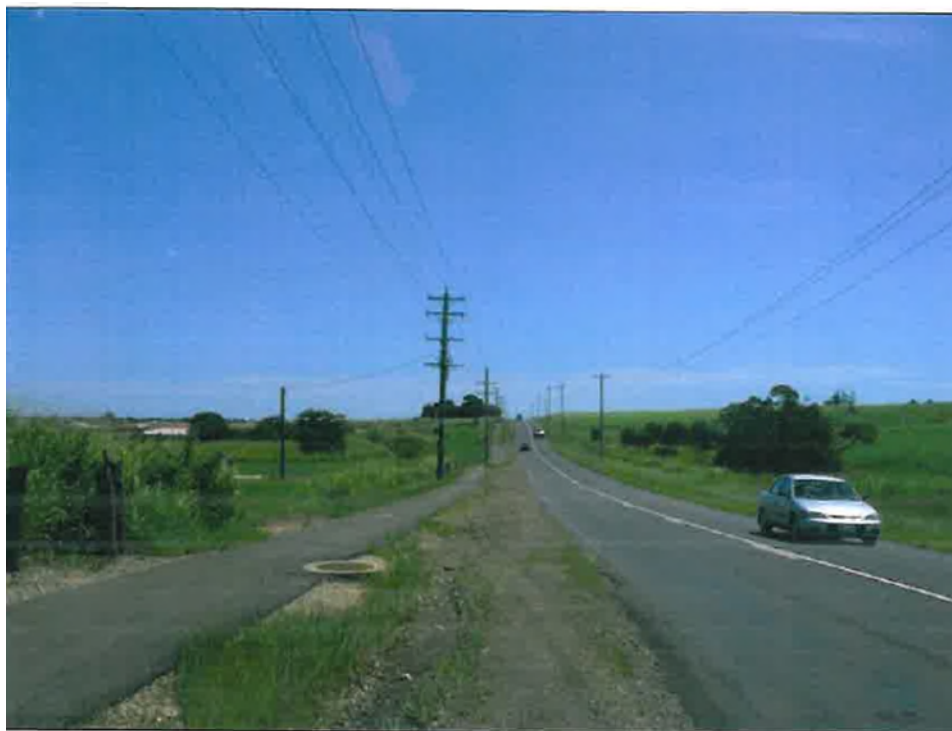
Figure 5.1: Main Street Hervey Bay – Existing Formation

Records obtained from FCRC indicate that the existing road pavement exhibited extensive pavement failures, cracking and patching with no residual life. The existing formation is shown in figure 5.1.

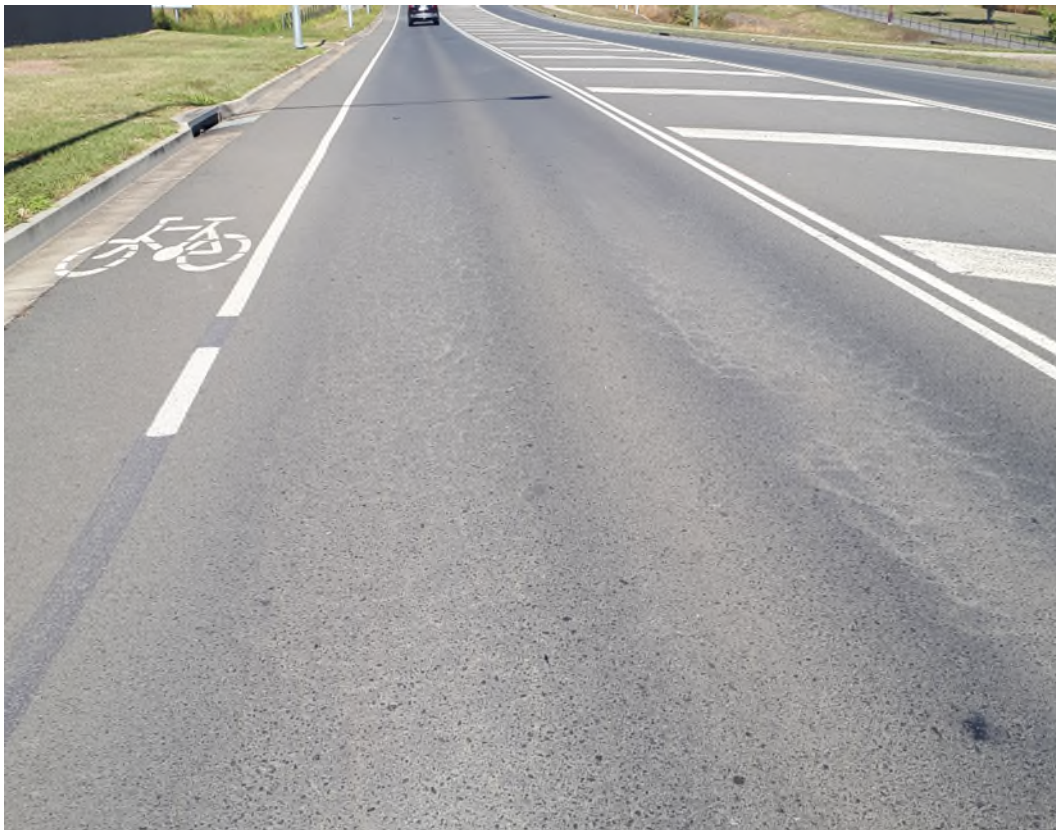
Figure 5.3: Main Street Hervey Bay – Pavement Condition

A site investigation of Main St Hervey Bay revealed that there are extensive pavement failures present and by visual inspection, the road is unlikely to reach its expected service life. Figure 5.3 is indicative of the failures present. The site visit record can be found in the appendix.

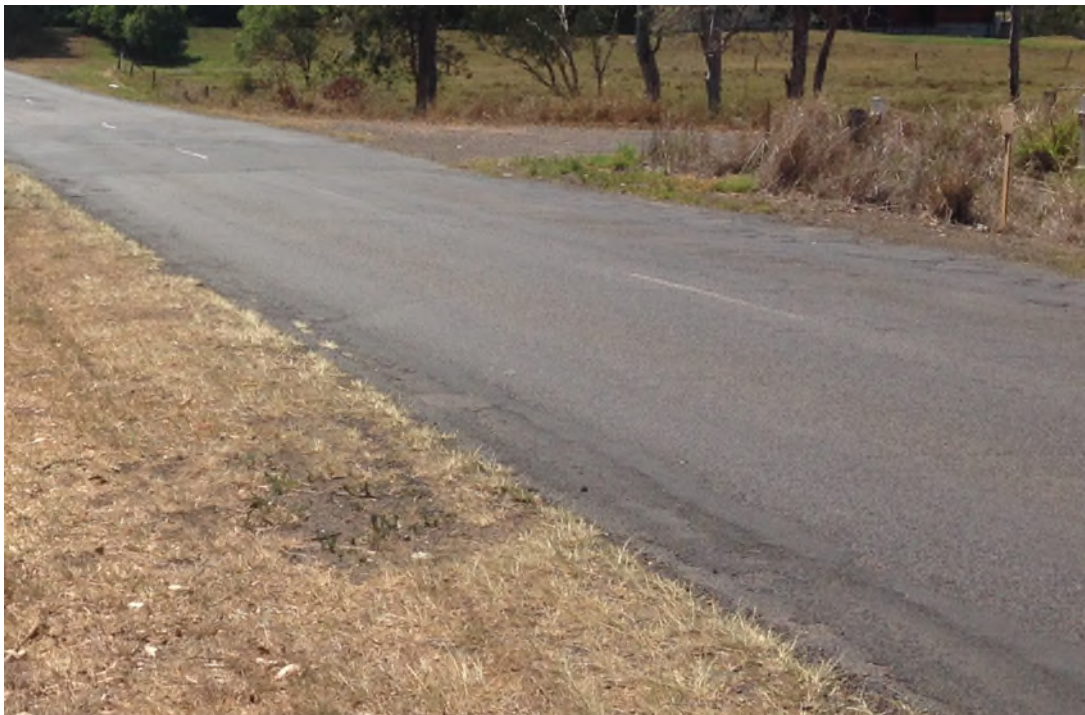
Figure 5.6: Chapel Road Hervey Bay - Existing Formation

Chapel Road Hervey Bay was identified for reconstruction in the 15/16 financial year due to the range of extensive pavement failures and poor shape of the existing road, as indicated in figure 5.6. Chapel Road is a collector road which connects the main road between Maryborough and Hervey Bay with many connection roads.

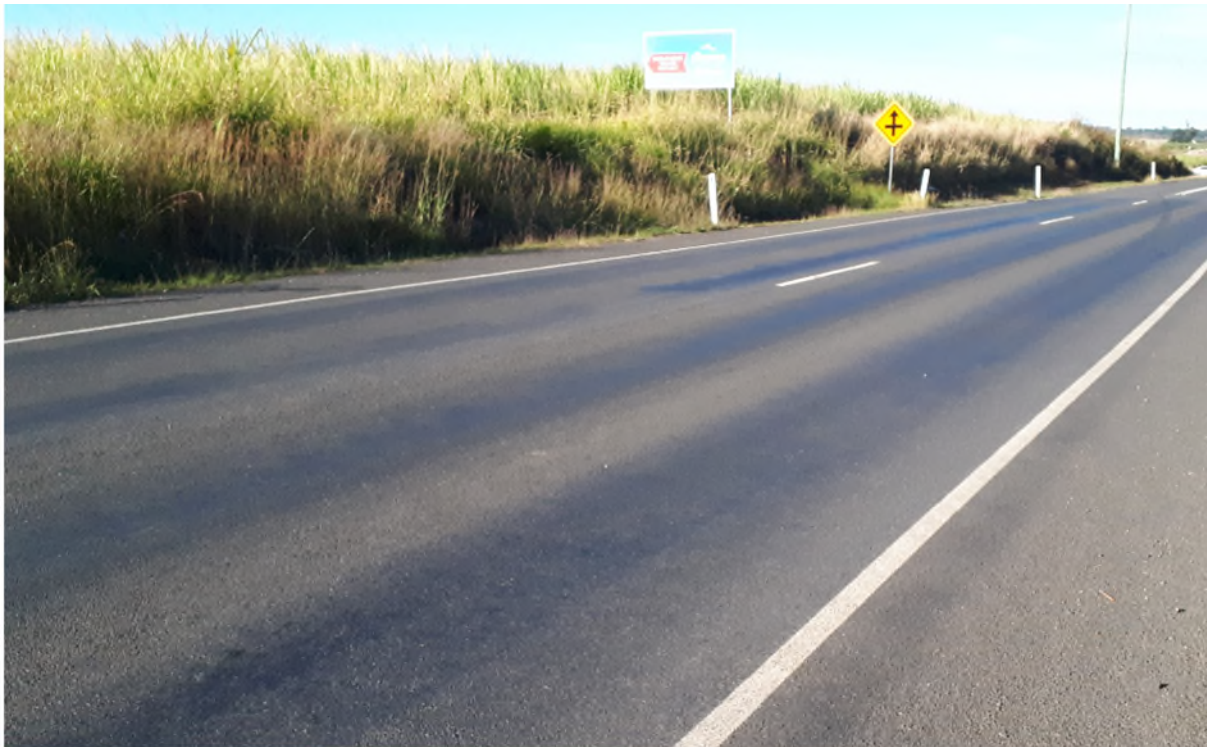
Figure 5.8: Chapel Road Hervey Bay – Pavement Condition

A site investigation of Chapel Road Hervey Bay revealed that the reconstructed road pavement has exhibited little evidence of deformation and has retained its shape fairly well. However, there is evidence of extensive flushing in the wheel paths over the entire length of the project, as shown in figure 5.8. The site visit record and pavement defect mapping sheet may be found in the appendix.

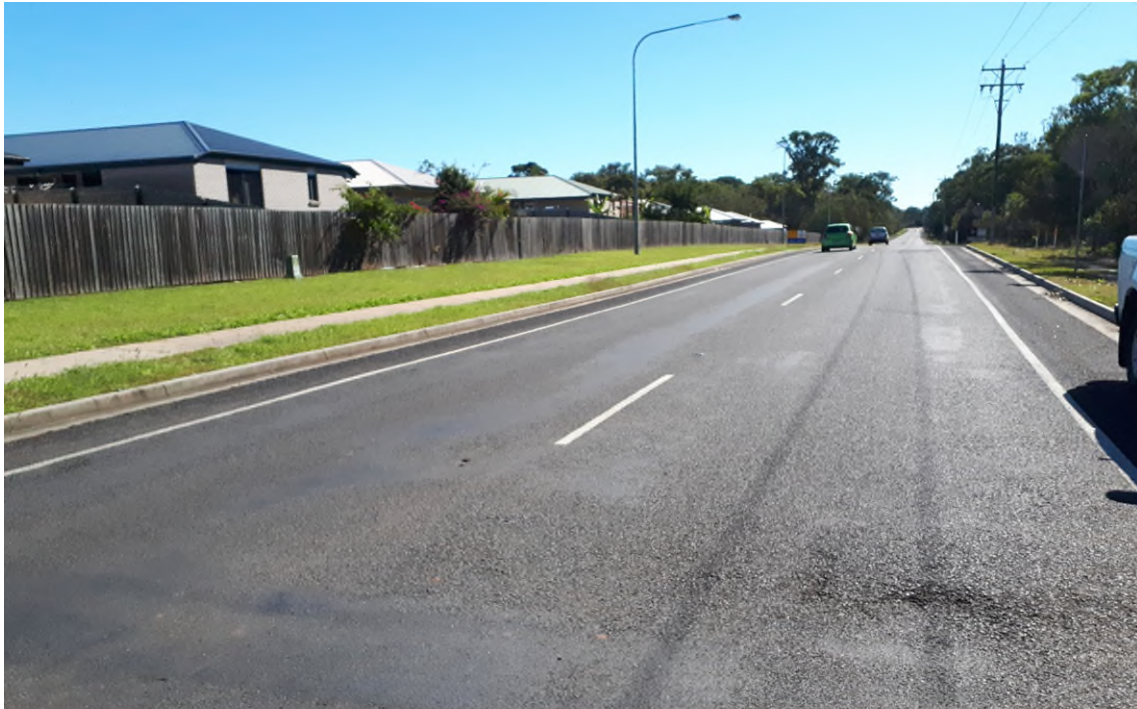
Figure 5.11: South Doolong Road Hervey Bay – Pavement Condition

A site investigation of South Doolong Road Hervey Bay revealed that the reconstructed road pavement has exhibited little evidence of deformation and has generally retained its shape. However, there is evidence of some flushing in the wheel paths, ravelling and minor rutting, as shown in Figure 5.11. The site visit record and pavement defect mapping sheet may be found in the appendix.

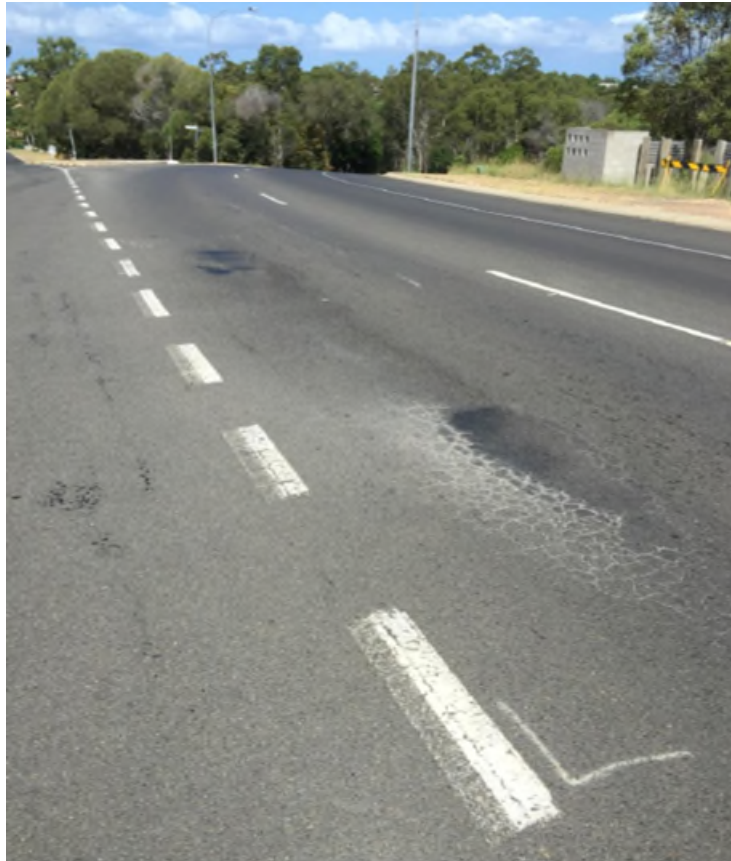
Figure 5.13: Oleander Avenue Hervey Bay - Existing Formation

Oleander Avenue Hervey Bay was identified for reconstruction as part of FCRC's 2015/2016 financial year capital program. The existing road formation had demonstrated extensive failures, crocodile cracking and patching as shown in Figure 5.13. Oleander Avenue is a controlled distributor road in the network's hierarchy and is a significant piece of infrastructure which allows transport from the suburb of Urangan to Pialba.

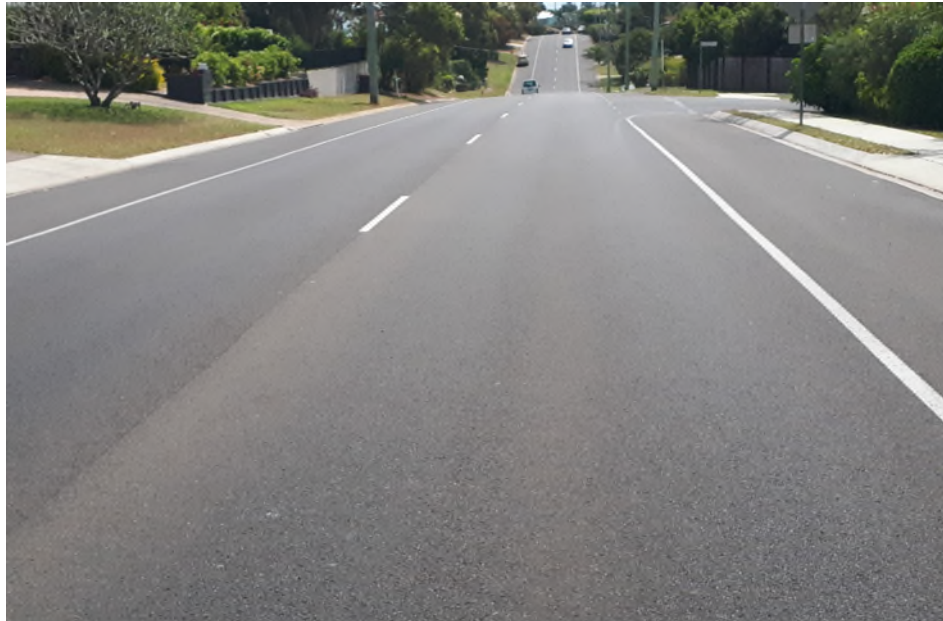
Figure 5.15: Oleander Avenue Hervey Bay – Pavement Condition

A site investigation of Oleander Avenue Hervey Bay revealed that the reconstructed road pavement has exhibited little evidence of deformation and is in good condition. There was no evidence of surface or pavement failures, as indicated in Figure 5.15. The site visit record and pavement defect mapping sheet may be found in the appendix.

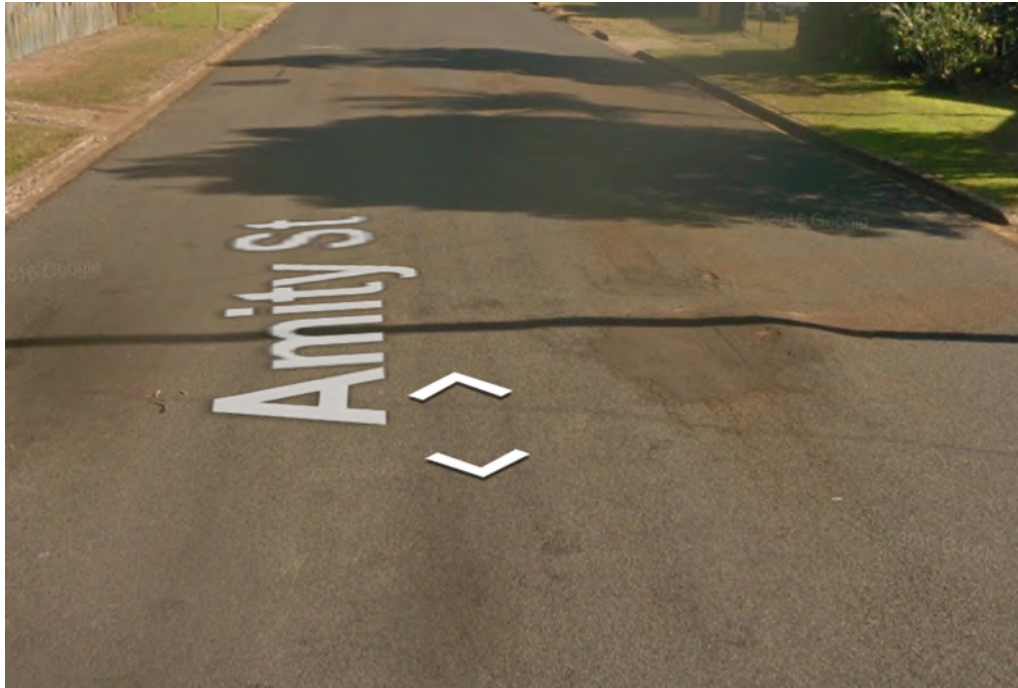
Figure 5.15: Amity St Maryborough - Existing Formation (Google, 2020)

Amity Street Maryborough was identified as being in need of reconstruction as part of Council's 2014/2015 capital works program. The existing road had demonstrated severe failures and was at the end of its serviceable life, as indicated in figure 5.15. FCRC records do not contain photos of Amity St prior to reconstruction, however Google Street View was used to provide a look at the condition of the pavement. Amity St is a residential street located in suburban Maryborough which sees high levels of passenger cars due to its close locality to a school.

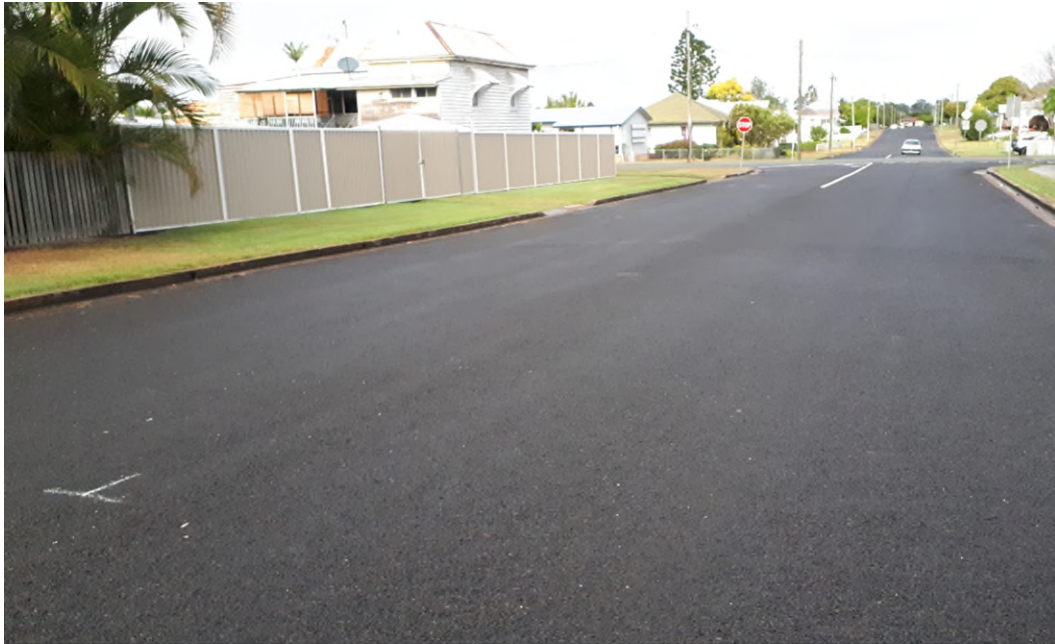
Figure 5.17: Amity Street Maryborough – Pavement Condition

A site investigation to Amity St Maryborough revealed that the constructed pavement exhibited minimal deflection or failures and that the seal surface was generally in good condition, as indicated in Figure 5.17.

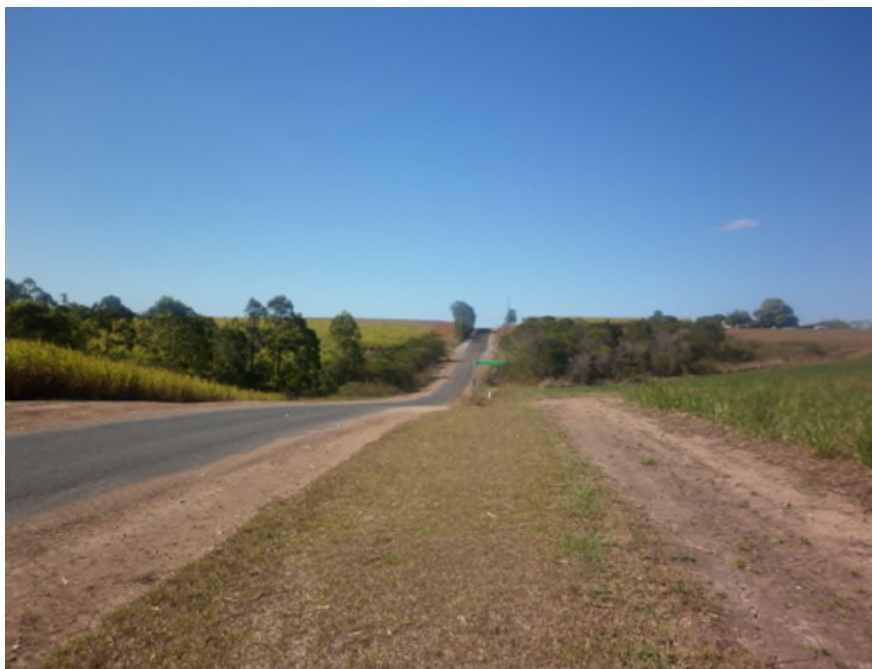
Figure 5.18: Yerra Road Maryborough - Existing Formation

Yerra Road Maryborough was identified as in need of reconstruction as part of Council's 2015/2016 financial year capital program. Yerra Road is a Rural Arterial road in the network hierarchy and is an important piece of infrastructure as it connects the rural community with Mungar and Maryborough. Yerra Road has a high volume of heavy vehicles due to the cane farms in the area as well as a local quarry being located on the road. The existing road formation, shown in Figure 5.18 was a 6.0m formation with unsealed shoulders and an undulating surface.

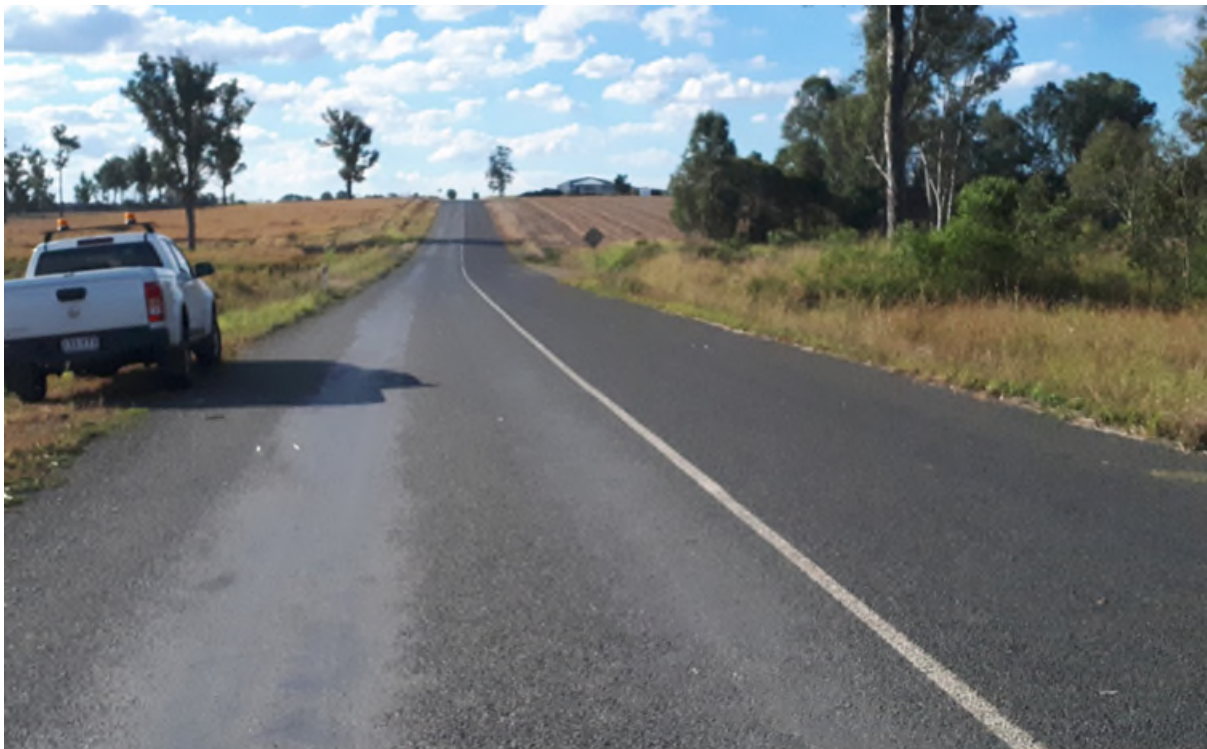
Figure 5.20: Yerra Road Maryborough – Pavement Condition

A site investigation to Yerra Road Maryborough revealed that the constructed pavement exhibited signs of pavement failure and surface distress, as shown in Figure 5.20.

While there is minimal cracking, it can be seen there is evidence of flushing and some deformation and rutting, indicating a possible subgrade failure. Condition testing data was obtained from FCRC to compare with the physical site visit undertaken. Figure 5.21 is a plot of rut depths measured in 2017 plotted against manually measured rut depths in 2020.
